Road & Railroad Crossing Inventory Mauvais & Big Coulee

**Bureau of Reclamation
Dakotas Area Office**

September 1999

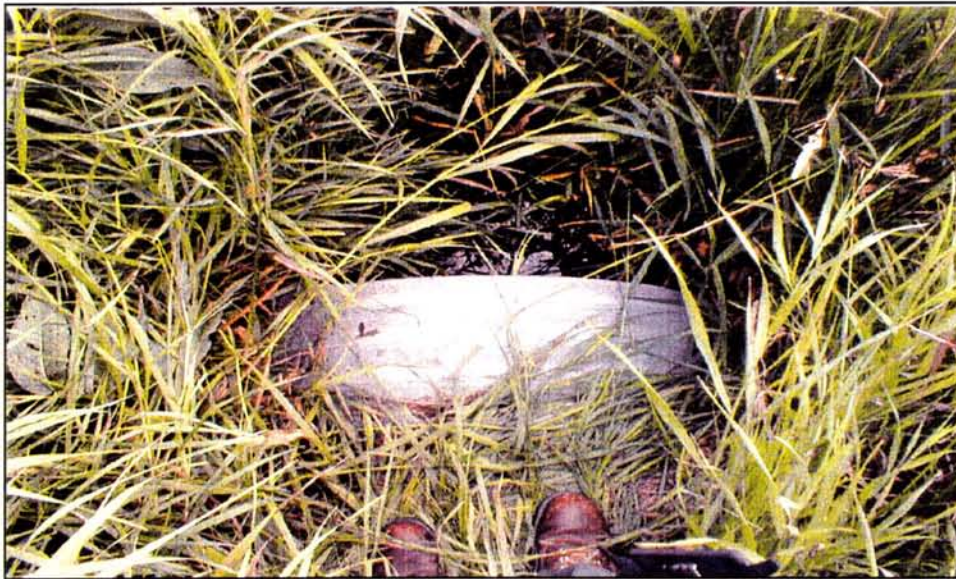
M20 Downstream side of one 36" CMP, in good condition, 1.7 feet of water (8-2-99), Section 9 & 16, T159N, R66W, N 587192.06, E 2317576.01, Elevation 1488.2 @ invert of CMP.

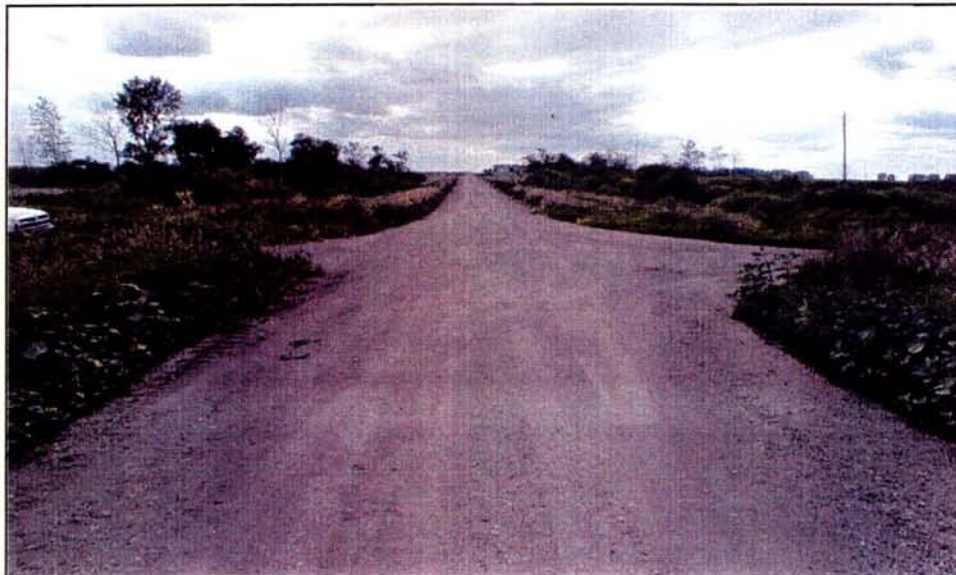
M20 Center of road crossing, on 36" CMP, CMP is east of intersection looking west, Section 9 & 16, T159N, R66W, N 587214.77, E 2317578.11, Elevation 1495.7 @ center of road crossing.

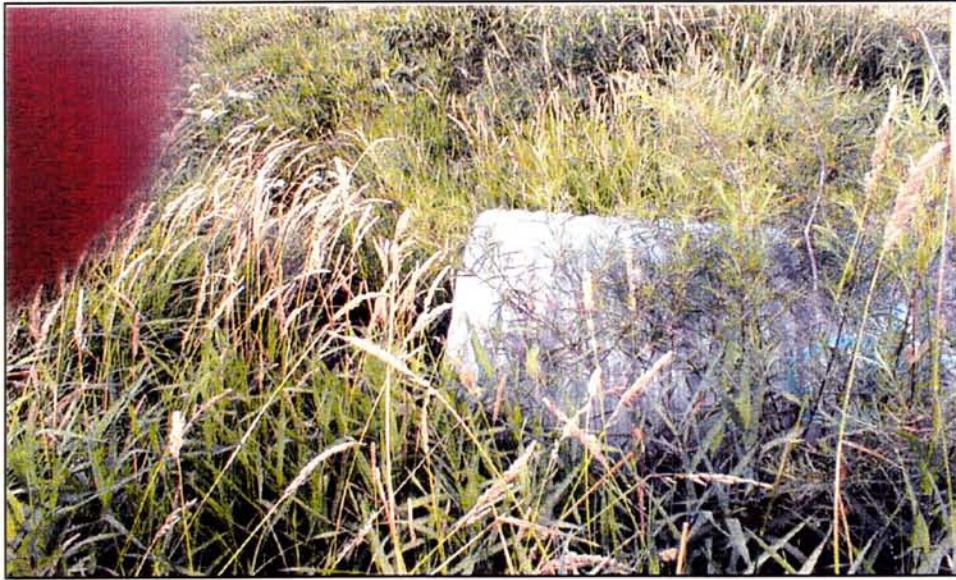
M21 Upstream side of one 48" CMP, in good condition, 0.9 foot of water (8-2-99), Section 8 & 16, T159N, R66W, N 587244.43, E 2317514.69, Elevation 1488.9 @ invert of CMP.

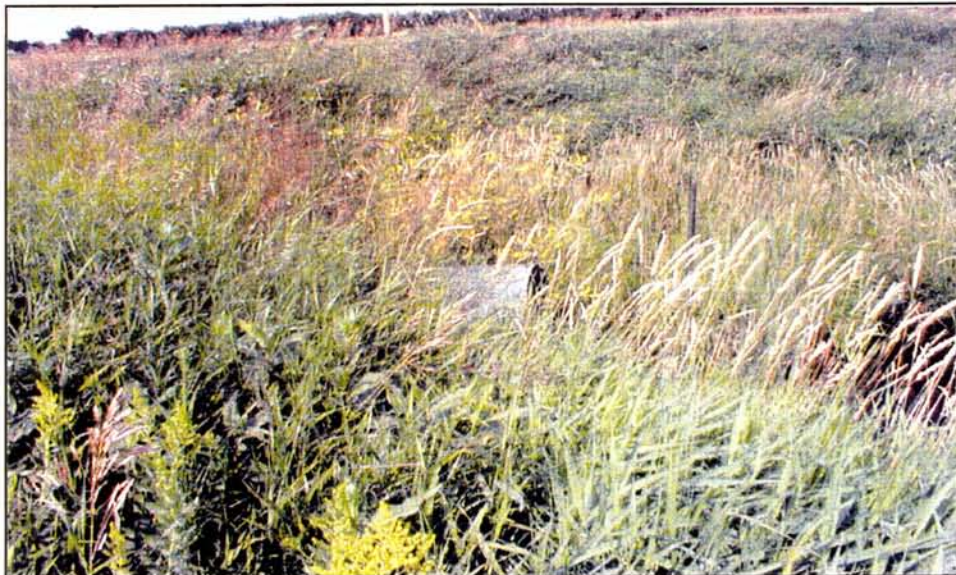
M21 Downstream side of one 48" CMP, in good condition, 1 foot of water (8-2-99), Section 8 & 16, T159N, R66W, N 587184.86, E 2317569.03, Elevation 1488.8 @ invert of CMP.

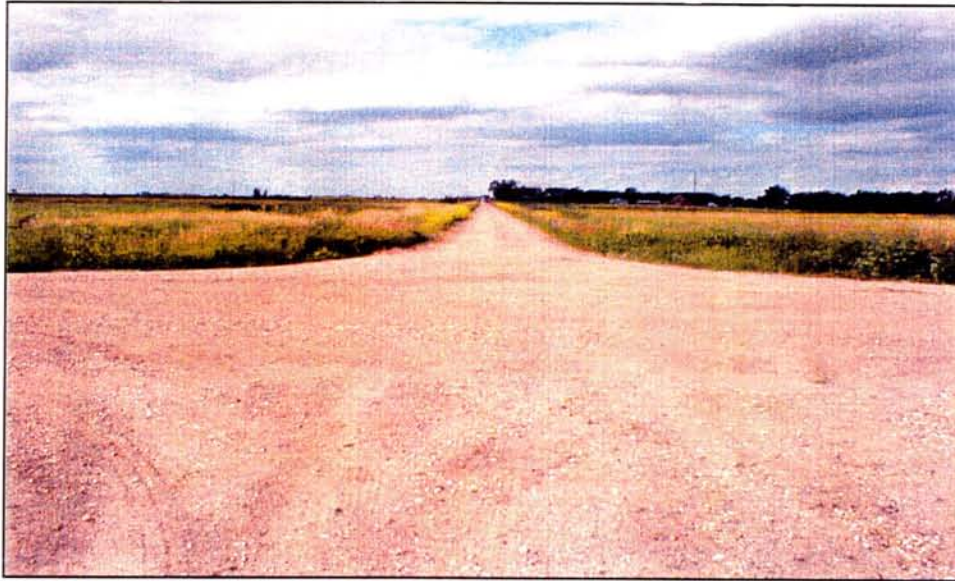
M21 Center of road crossing on one 48" CMP, looking north, CMP runs N-W to S-E diagonal, Section 8 & 16, T159N, R66W, N 587215.06, E 2317546.55, Elevation 1495.5 @ center of road crossing.

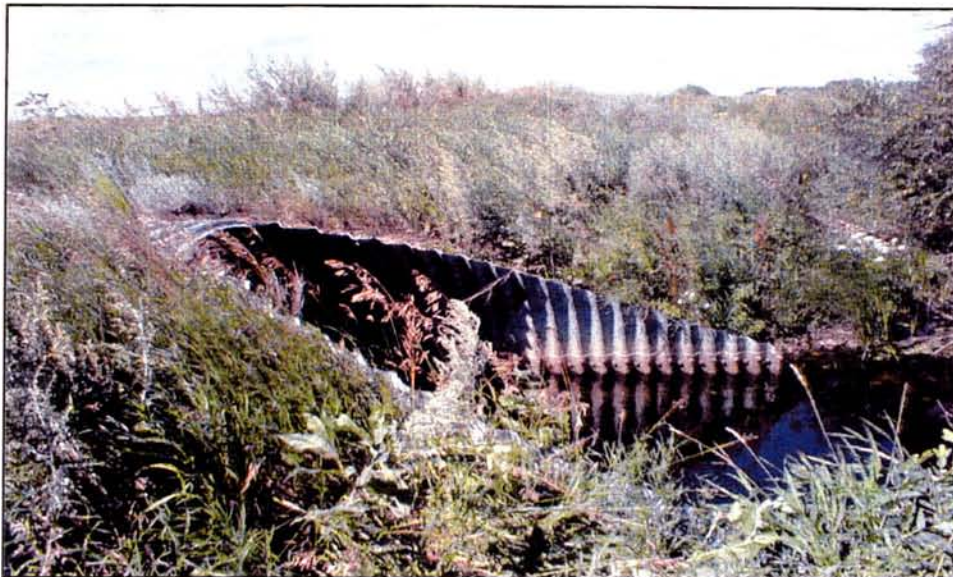
M22 Upstream side of one 96" CMP, in good condition, 1.3 feet of water (8-2-99), Section 8 & 17, T159N, R66W, N 587223.53, E 2317085.55, Elevation 1488.0 @ invert of CMP.

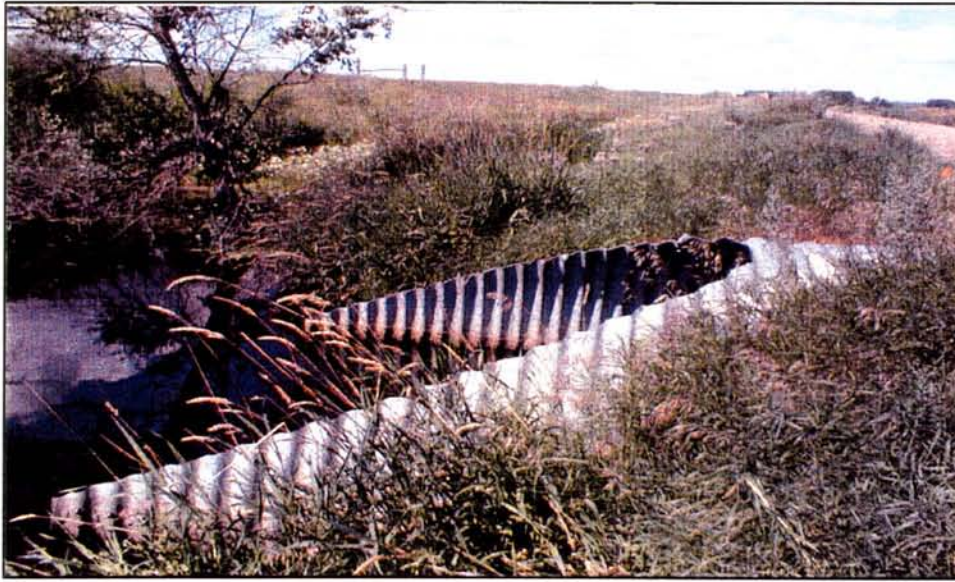
M22 Downstream side of one 96" CMP, in good condition, 1.4 feet of water (8-2-99), Section 8 & 17, T159N, R66W, N 587190.80, E 2317088.75, Elevation 1488.0 @ invert of CMP.

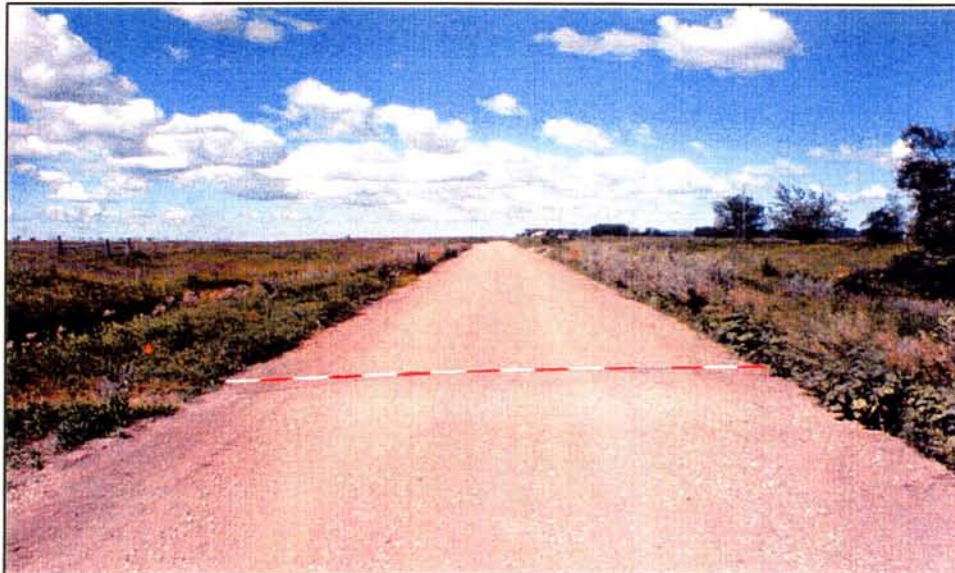
M22 Center of road crossing of one 96" CMP looking west, Section 8 & 17, T159N, R66W, N 587207.81, E 2317086.39, Elevation 1497.0 @ center of road crossing.

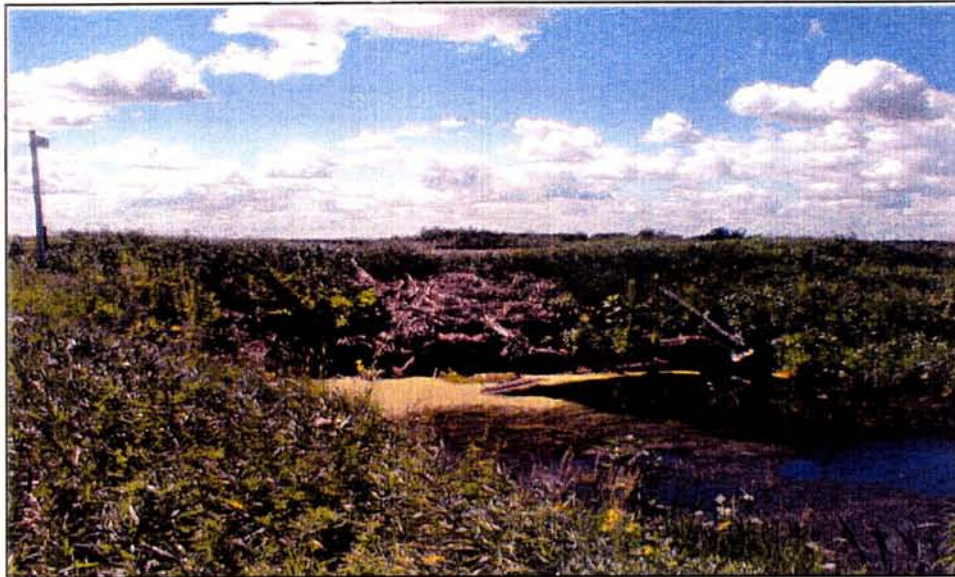
M23 Upstream side of four 60" concrete pipes at railroad crossing, in fair condition, 4+ feet of water (8-3-99), Section 5, T159N, R66W, east to west northings & eastings, N 597290.43, E 2314325.38, Elevation 1499.0, N 597291.95, E 2314317.64, Elevation 1497.7, N 597292.77, E 2314312.72, Elevation 1497.5, N 597291.89, E 2314303.07, Elevation 1498.5 @ invert of 60" concrete pipes.

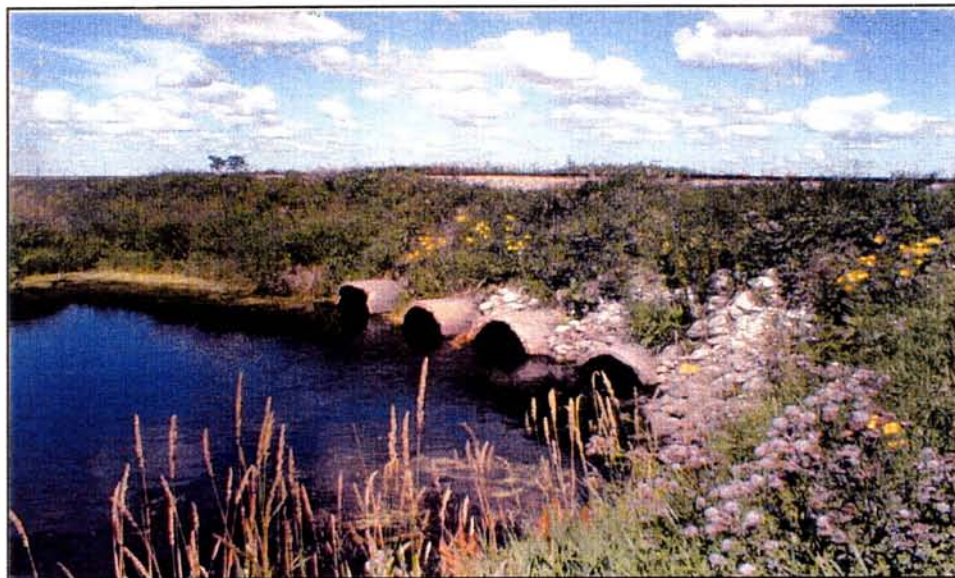
M23 Downstream side of four 60" concrete pipes at railroad crossing, in fair condition, 4+ feet of water (8-3-99), Section 5, T159N, R66W, east to west northings & eastings, N 597250.57, E 2314326.28, Elevation 1498.3, N 597250.98, E 2314319.13, Elevation 1497.9, N 597249.85, E 2314313.33, Elevation 1498.0, N 597250.99, E 2314305.05, Elevation 1498.0 @ invert of 60" concrete pipes.

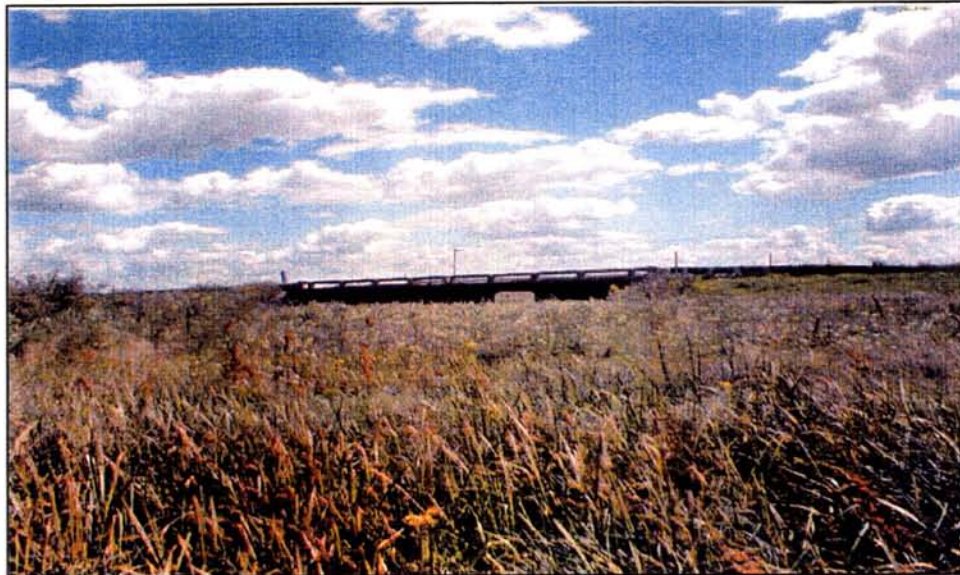
M24 Upstream side of concrete bridge at N.D. Hwy. 66, in good condition, 1.8 foot of water, (8-3-99), Section 32 & 5, T160N & 159N, R66W, N 597778.92, E 2314000.49, Elevation 1500.4 @ ∇ of bridge.

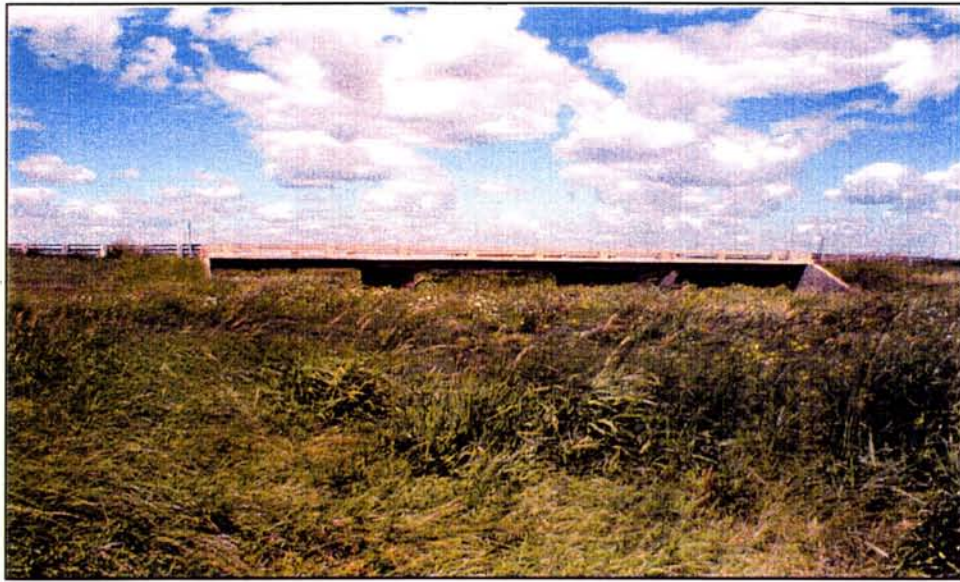
M24 Downstream side of concrete bridge at N.D. Hwy. 66, in good condition, 1 foot of water (8-3-99), Section 32 & 5, T160N & 159N, R66W, N 597742.87, E 2314001.07, Elevation 1501.3 @ \perp of bridge.

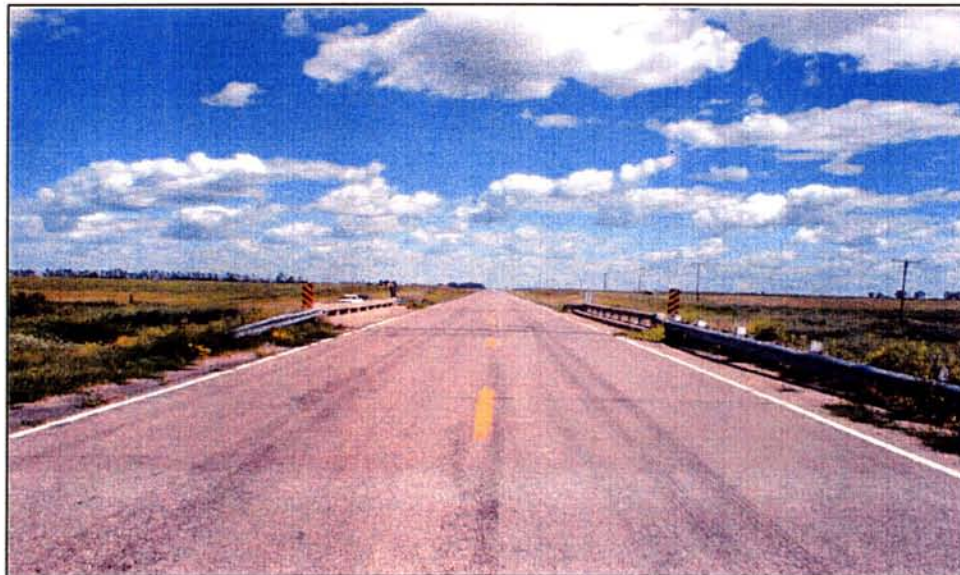
M24 Center of concrete bridge at N.D. Hwy. 66, looking east, in good condition, 36.4 feet wide & 85 foot long, Section 32 & 5, T160N & 159N, R66W, N 597760.14, E 2314001.27, Elevation 1509.4 @ \perp of bridge & N.D. Hwy. 66.

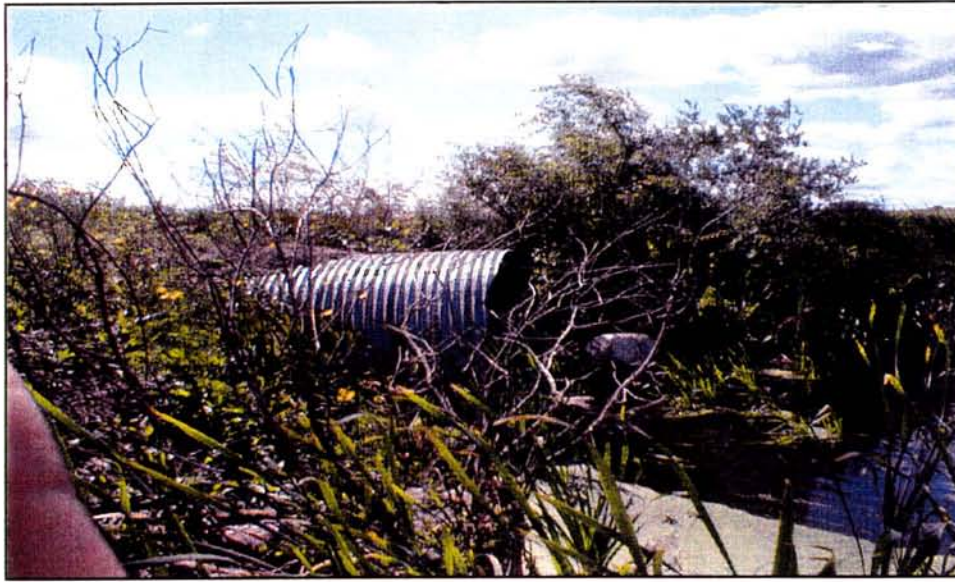
M25 Upstream side of one 72" CMP, in good condition, 0.8 foot of water (8-3-99), Section 20 & 29, T160N, R66W, N 608351.90, E 2313903.33, Elevation 1509.5 @ invert of CMP.

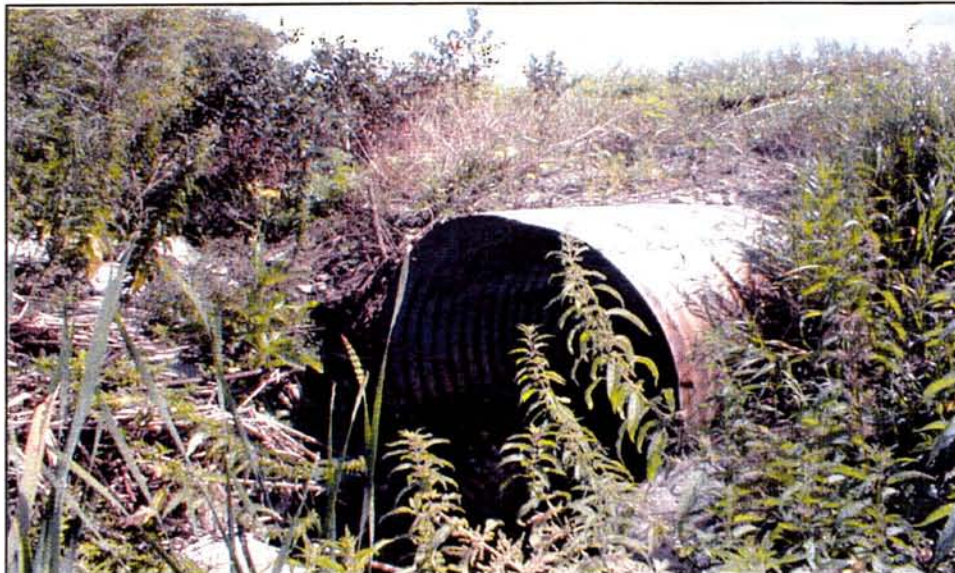
M25 Upstream side of one 48" CMP, in good condition, no water (8-3-99), Section 20 & 29, T160N, R66W, N 608348.96, E 2313864.04, Elevation 1510.5 @ invert of CMP.

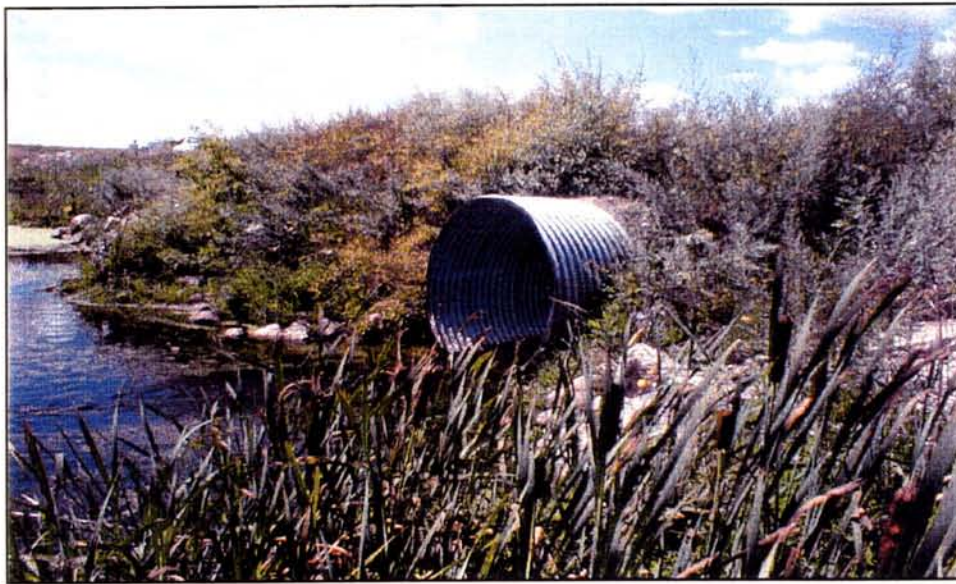
M25 Downstream side of one 72" CMP, in good condition, 0.5 foot of water (8-3-99), Section 20 & 29, T160N, R66W, N 608306.70, E 2313906.04, Elevation 1509.7 @ invert of CMP.

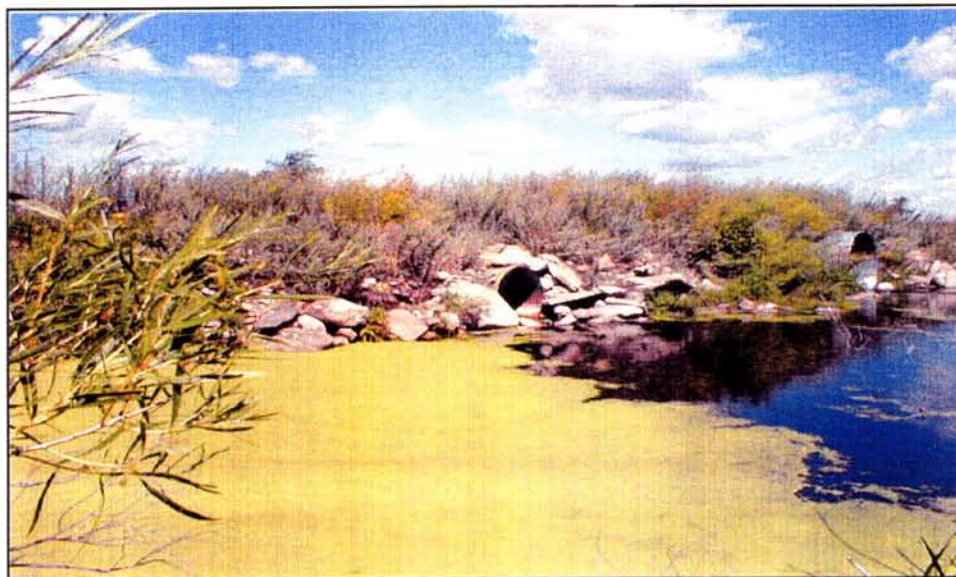
M25 Downstream side of one 48" CMP, in good condition, 1.1 foot of water (8-3-99), Section 20 & 29, T160N, R66W, N 608306.28, E 2313868.35, Elevation 1509.1 @ invert of CMP.

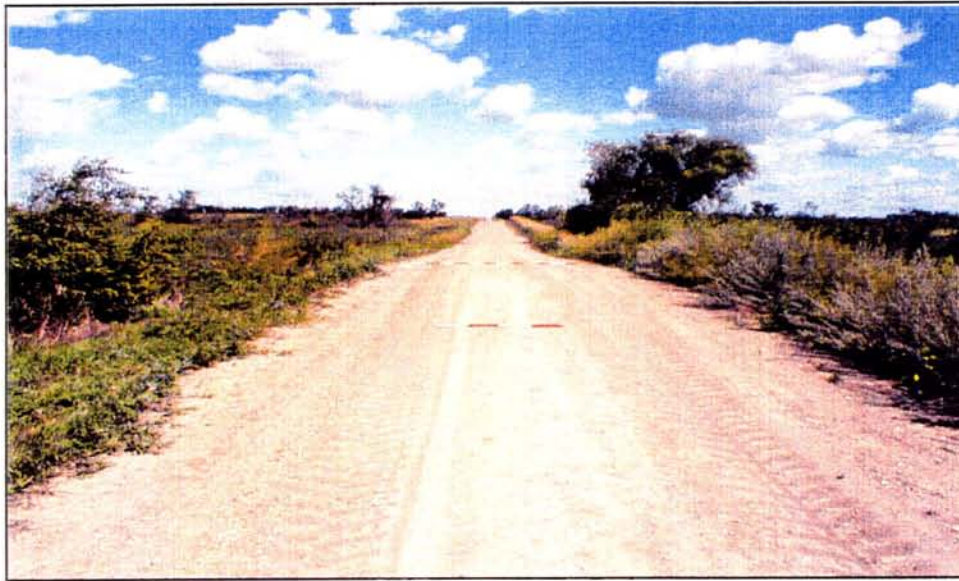
M25 Center of gravel road, of 48" CMP and 72" CMP, looking east,
Section 20 & 27, T160N, R66W, N 608328.14, E 2313865.75, Elevation
1517.1 @ center of gravel road and 48" CMP, N 608328.94,
E 2313904.20, Elevation 1517.3 @ center of gravel road and 72" CMP.

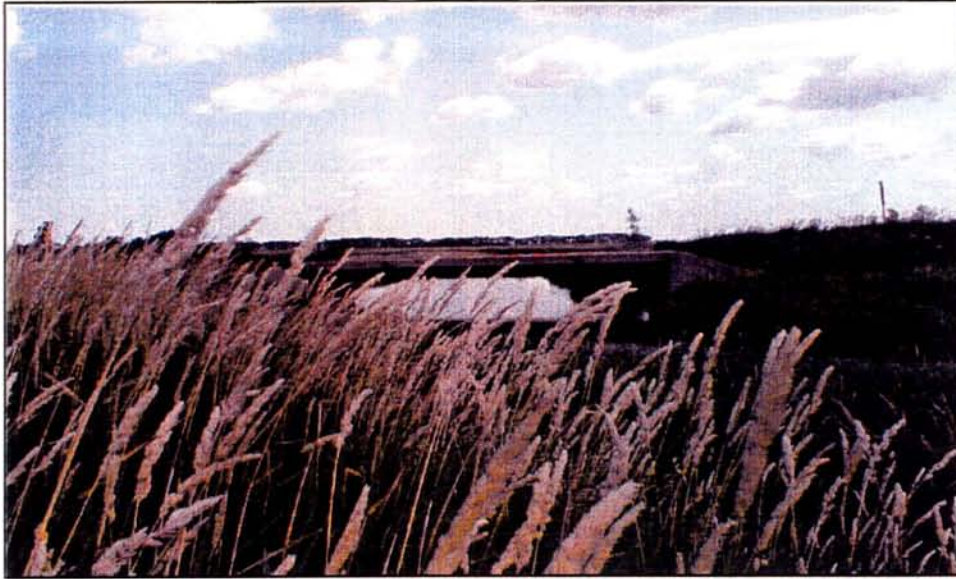
B1 Upstream side of concrete bridge, in fair condition, 4 feet of water (8-4-99), Section 8 & 9, T158N, R66W, N 557634.84, E 2318050.82, Elevation 1467.0 @ ∇ of Coulee & Bridge.

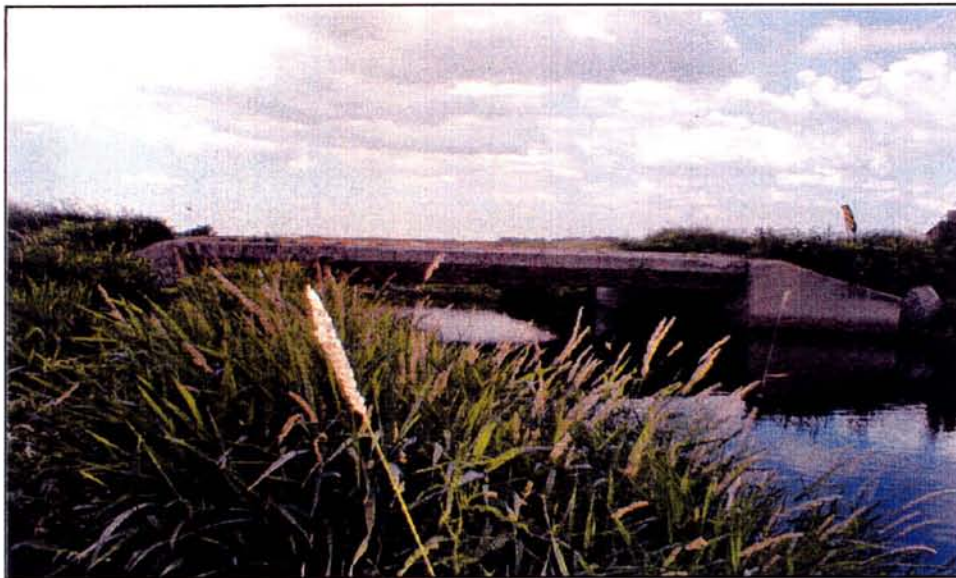
B1 Downstream side of concrete bridge, in fair condition, 4.8 feet of water (8-4-99), Section 8 & 9, T158N, R66W, N 557634.52, E 2318068.81, Elevation 1466.3 @ ∇ of Coulee Bridge.

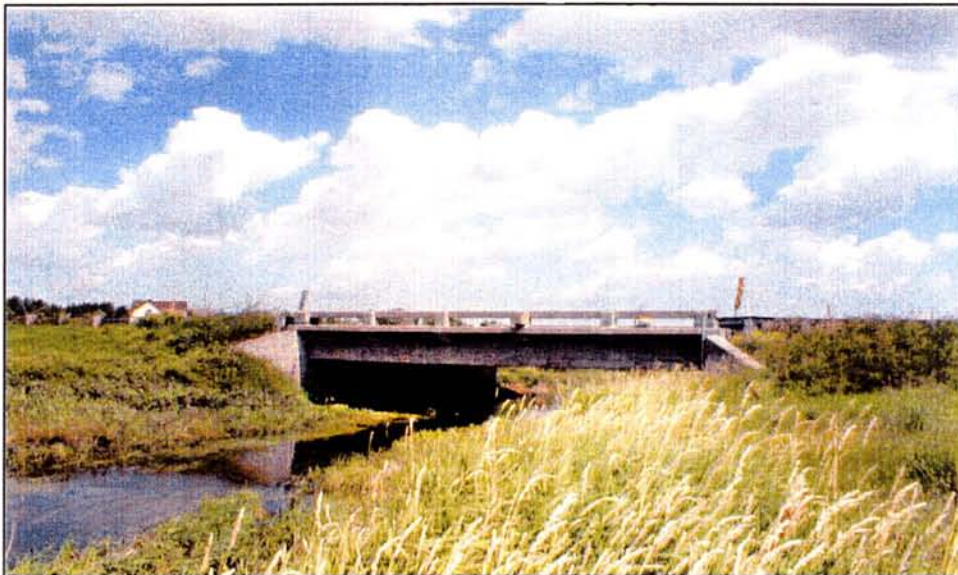
B2 Upstream side of concrete bridge at U.S. Hwy. 281, in good condition, 2.2 feet of water (8-4-99), Section 5 & 6, T158N, R66W, N 563694.30, E 2312654.58, Elevation 1473.4 @ Φ of bridge.

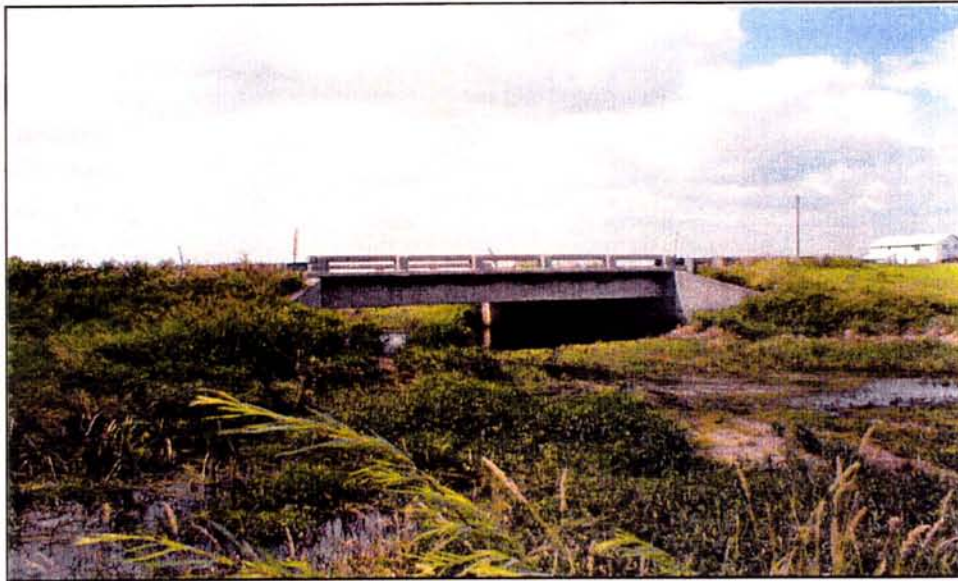
B1 Downstream side of concrete bridge at U.S. Hwy. 281, in good condition, 1.3 feet water (8-4-99), Section 5 & 6, T158N, R66W, N 563696.53, E 2312690.38, Elevation 1474.4 @ ∇ of bridge.

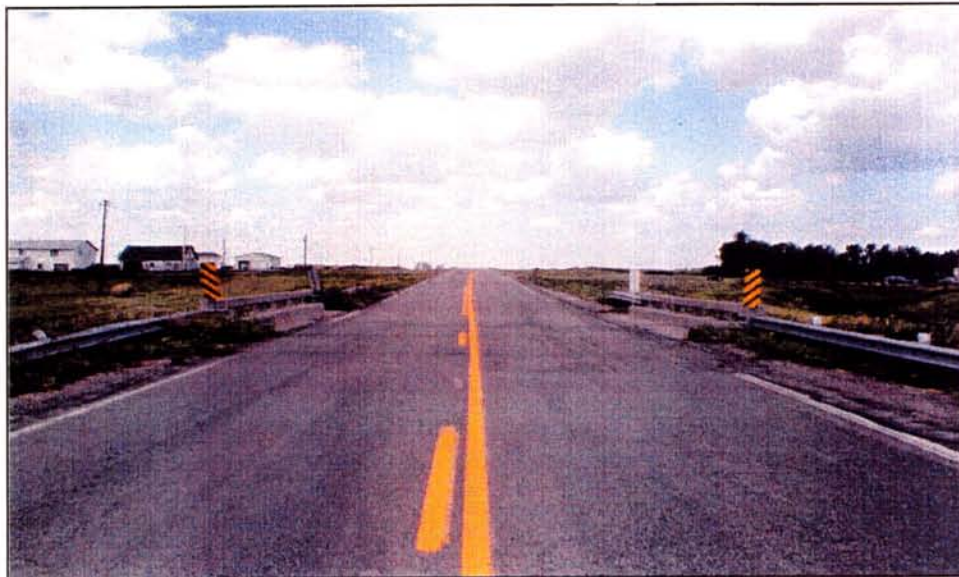
B2 Center of concrete bridge in good condition, looking north, 37.5 feet wide and 42.2 feet long, Section 5 & 6, T158N, R66W, N 563696.30, E 2312671.61, Elevation 1484.1 @ ∇ of bridge and U.S. Hwy 281.

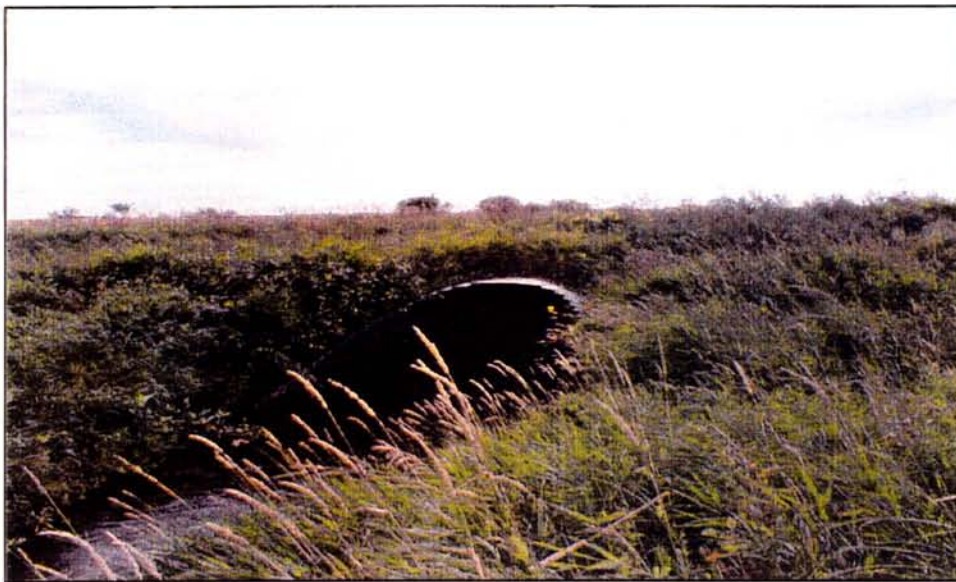
B3 Upstream side of one 102" CMP, in good condition, 2.7 feet of water, (8-17-99) Section 31 & 6, T158 & 159N, R66W, N 566008.56, E 2310600.80, Elevation 1475.3 @ invert of one 102" CMP.

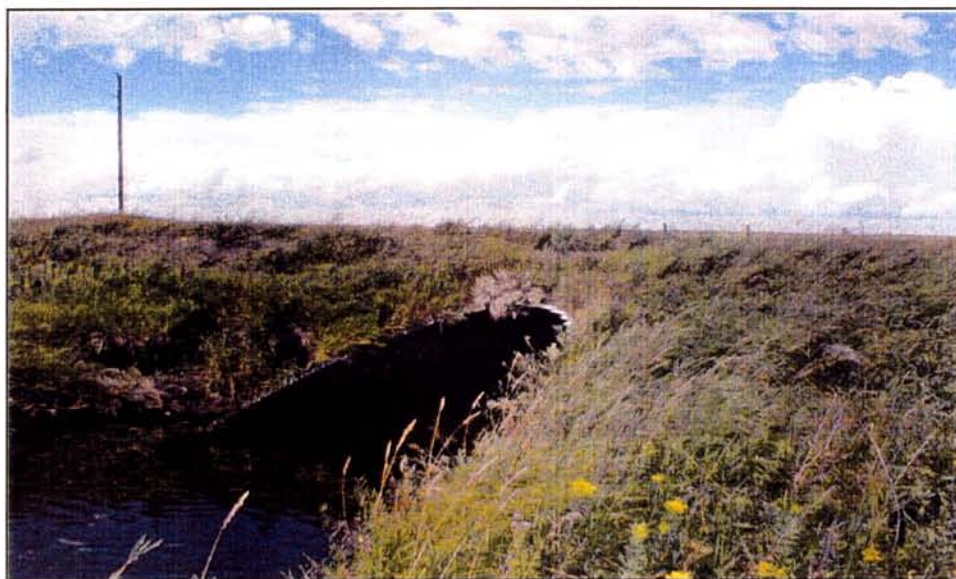
B3 Downstream side of one 102" CMP, in good condition, 2.5 feet of water, (8-17-99) Section 31 & 6, T158 & 159N, R66W, N 565973.67, E 2310596.70, Elevation 1475.7 @ invert of one 102" CMP.

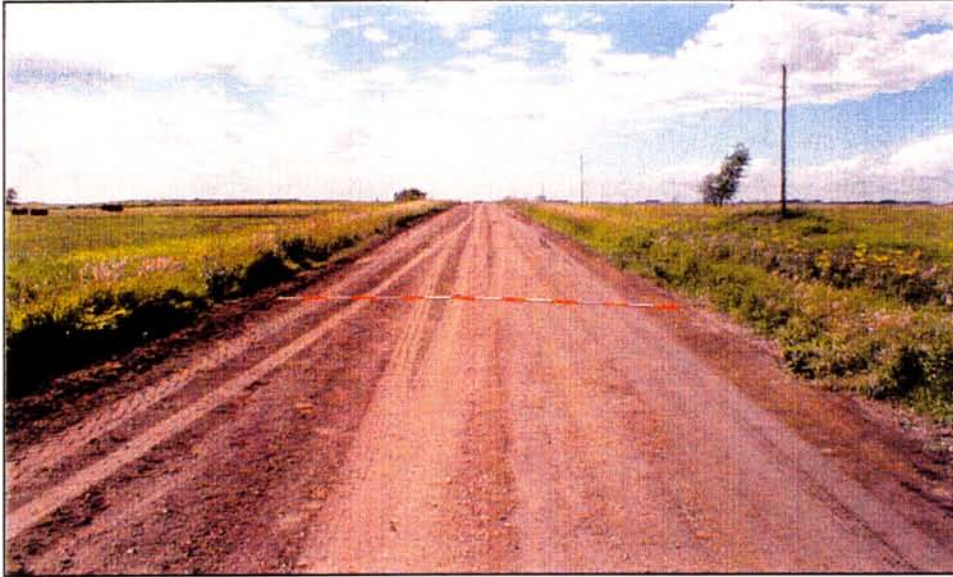
B3 Center of gravel road, looking west, Section 31 & 6, T158 & 159N, R66W, N 565990.17, E 2310598.85, Elevation 1486.4 @ center of gravel road.

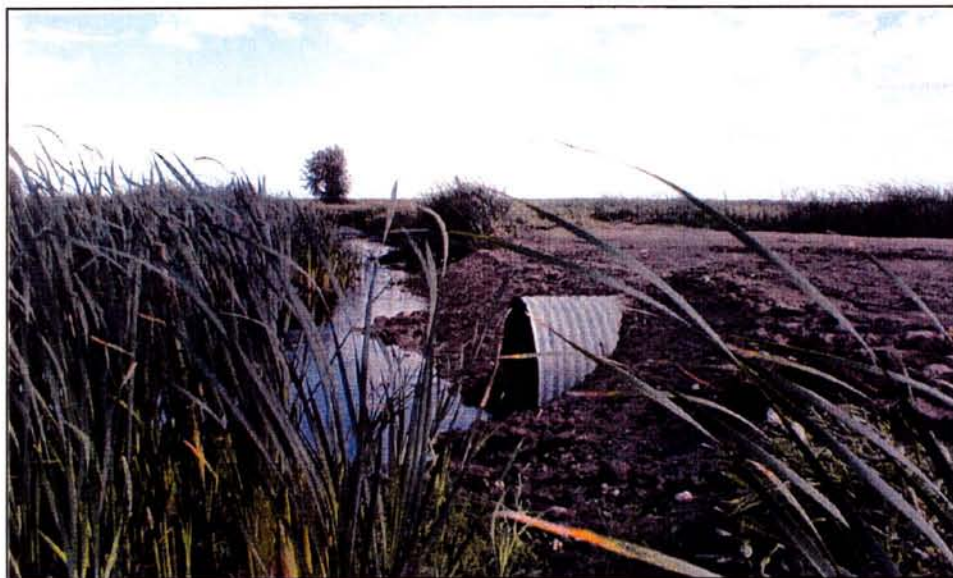
B4 Upstream side of one 48" CMP, in good condition, 0.3 foot of water (8-17-99), Section 25 & 36, T158 & 159N, N 571166.93, E 2302012.30, Elevation 1492.4 @ invert of 48" CMP.

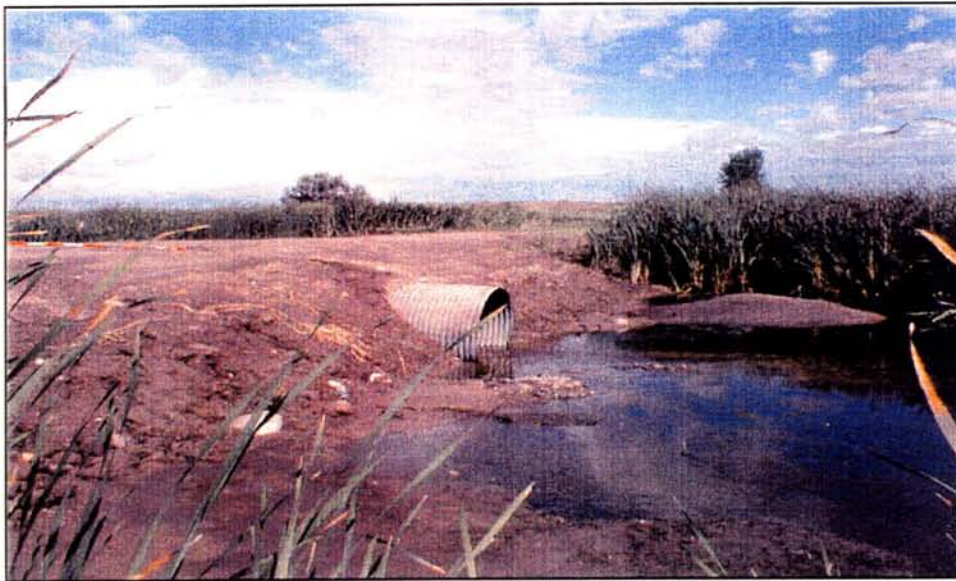
B4 Downstream side of one 48" CMP, in good condition, 1.2 foot of water (8-17-99), Section 25 & 36, T159N, R67W, N 571126.86, E 2302011.91, Elevation 1491.3 @ invert of 48" CMP.

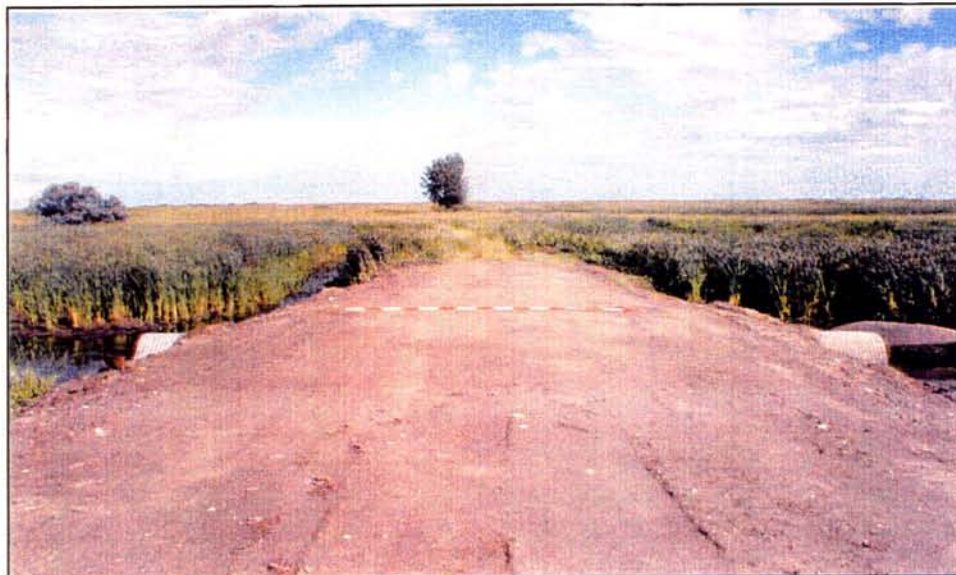
B4 Center of trail looking east, Section 25 & 36, T159N, R67W, N 571148.39, E 2302011.31, Elevation 1497.7 @ center of trail.

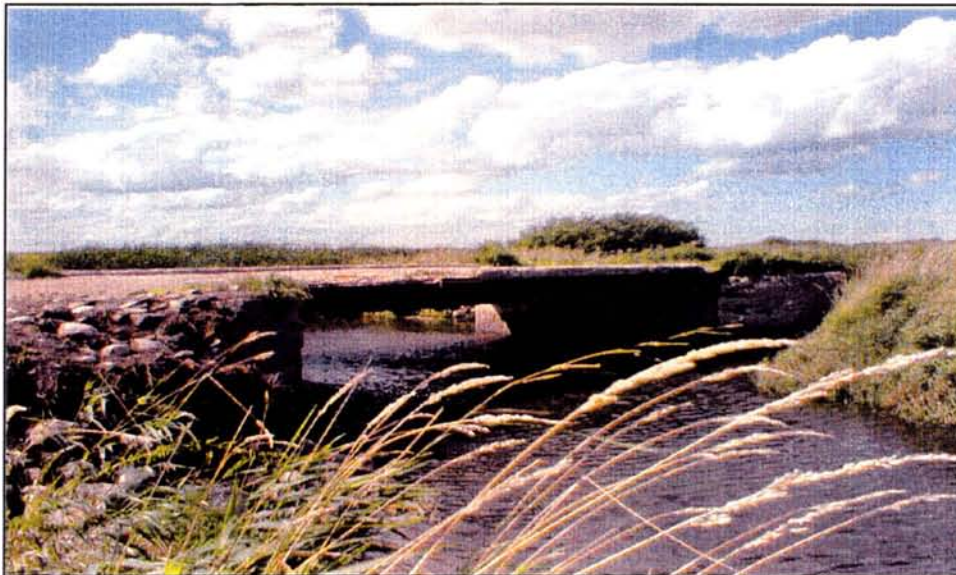
B5 Downstream side of concrete bridge, in fair condition, 6.7 feet of water (8-17-99), Section 23 & 24, T159N, R67W, N 580035.92, E 2301764.64, Elevation 1500.6 @ center of concrete bridge.

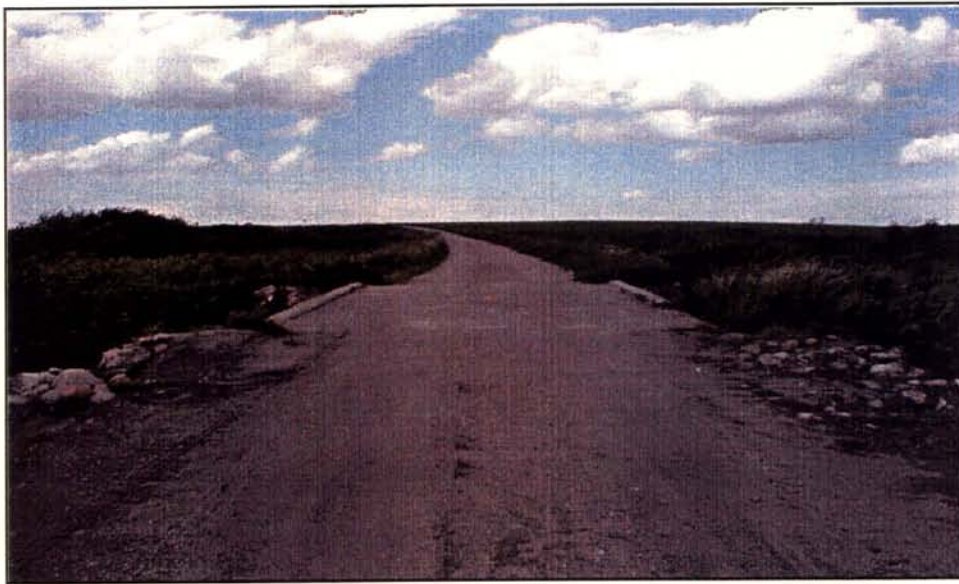
B5 Center of concrete bridge, 18' wide & 30' long, looking north, Section 23 & 24, T159N, R67W, N 580037.80, E 2301755.98, Elevation 1511.3 @ \perp of bridge.

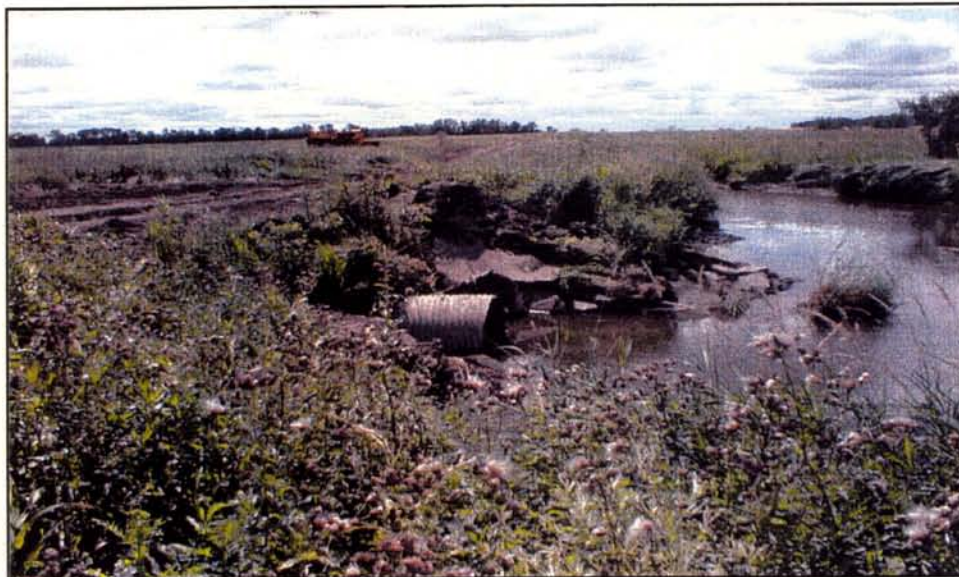
B6 Upstream side of one 48" CMP, in good condition, 1.8 feet of water (8-18-99), Section 22 & 23, T159N, R67W, N 580593.33, E 296442.95, Elevation 1509.9 @ invert of CMP.

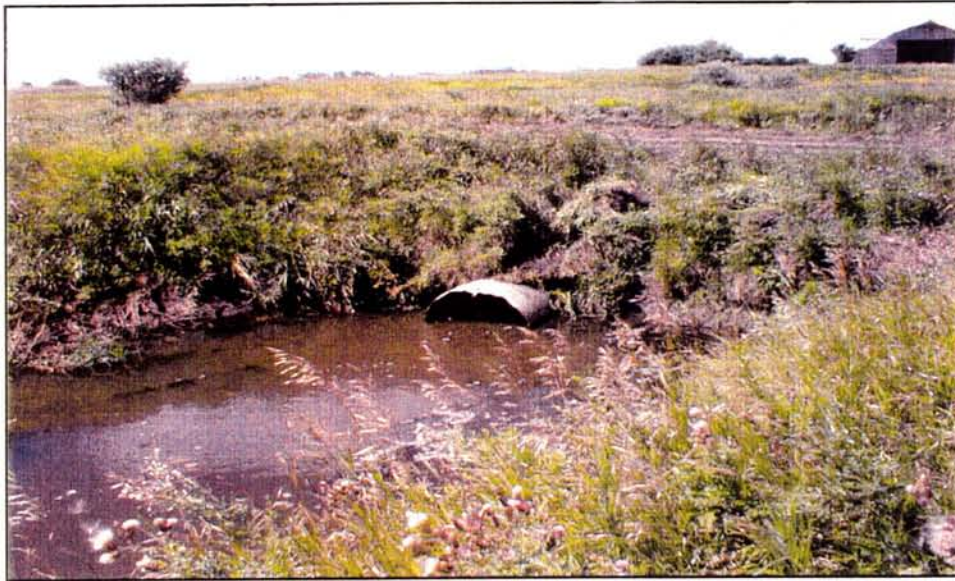
B6 Downstream side of one 48" CMP, in good condition, 2.5 feet of water (8-17-99), Section 22 & 23, T159N, R67W, N 580591.82, E 2296489.90, Elevation 1509.2 @ invert of CMP.

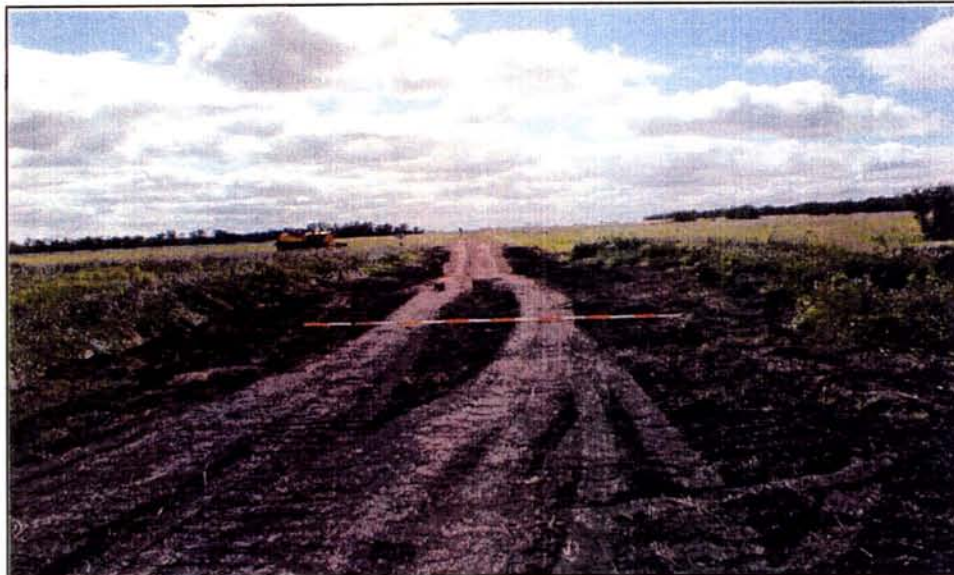
B6 Center of trail looking, south Section 22 & 23, T159N, R67W, N 580593.67, E 2296463.58, Elevation 1516.4 @ center of trail.

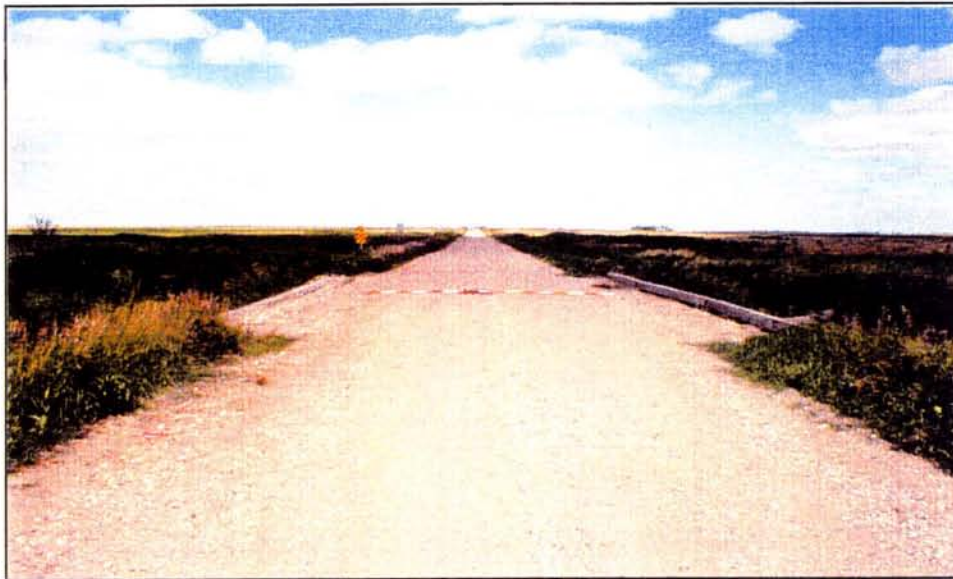
B7 Center of bridge in fair condition, looking north, 26.5' wide & 52' long, Section 15 & 16, T159N, R67W, N 584162.74, E 2291118.29, Elevation 1525.2 @ center of bridge.

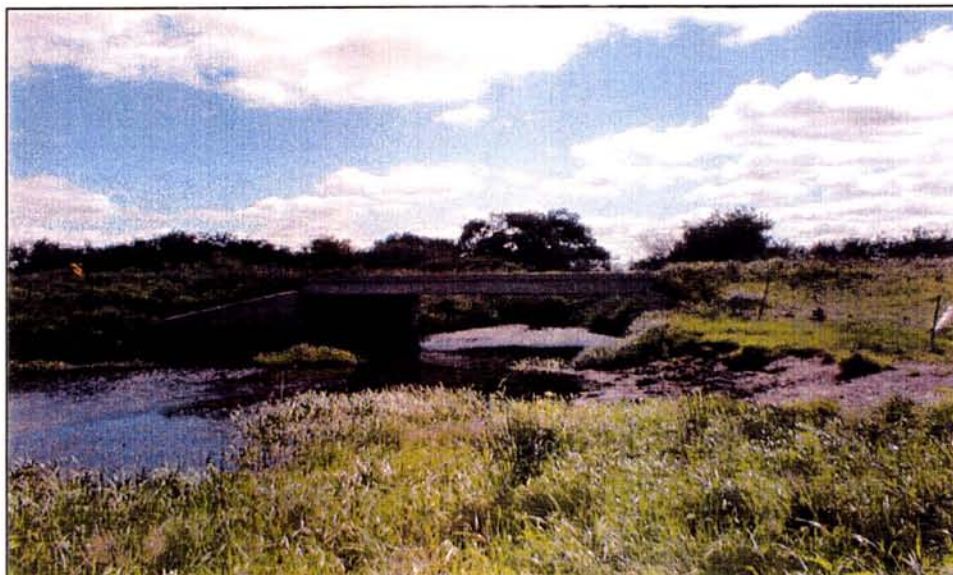
B8 Upstream side of concrete bridge, in good condition, 4.3 feet of water (8-18-99), Section 8 & 17, T159N, R67W, N 586739.58, E 2284847.15, Elevation 1524.2 @ ∇ of coulee.

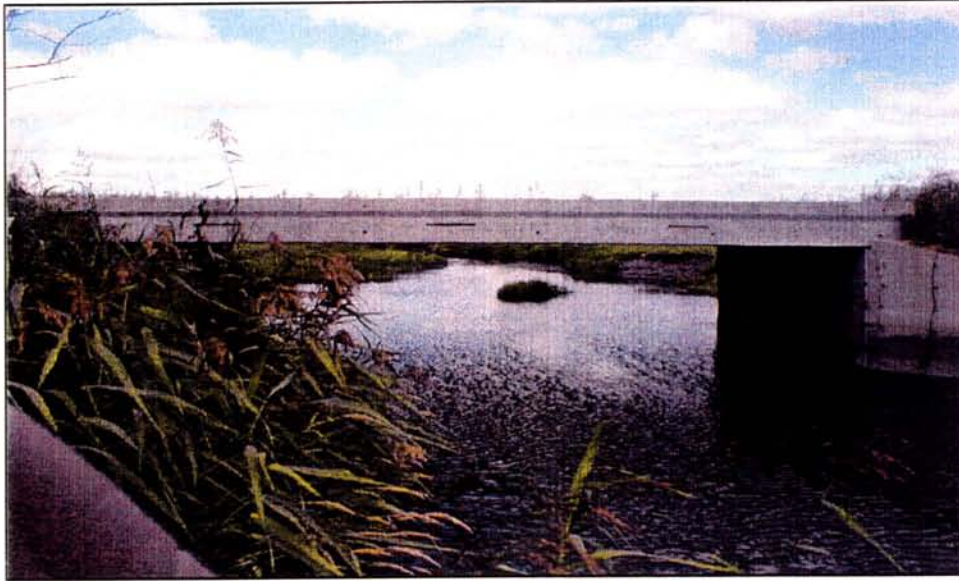
B8 Downstream side of concrete bridge, in good condition, 4.7 feet of water, (8-18-99), Section 8 & 17, T159N, R67W, N 586713.53, E 2284853.60, Elevation 1523.7 @ ∇ of coulee.

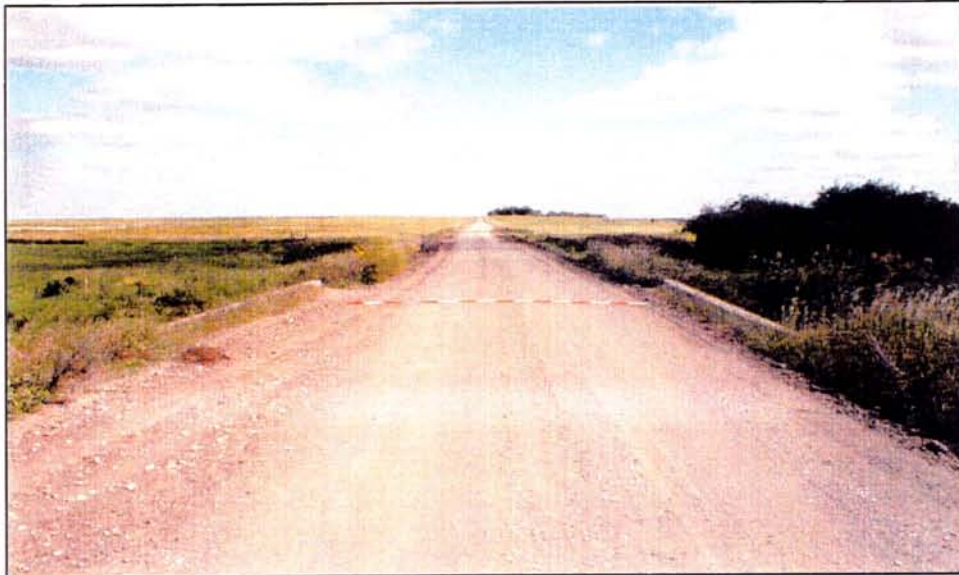
B8 Center of bridge in good condition, looking east, 25.5' wide & 36' long, Section 8 & 17, T159N, R67W, N 586725.44, E 2284847.46, Elevation 1536.6 @ center of bridge, top of gravel.
